Carp Aquaculture Overwhelms Lake Kolleru Andhra Pradesh, India

Environmental Hotspot Alert

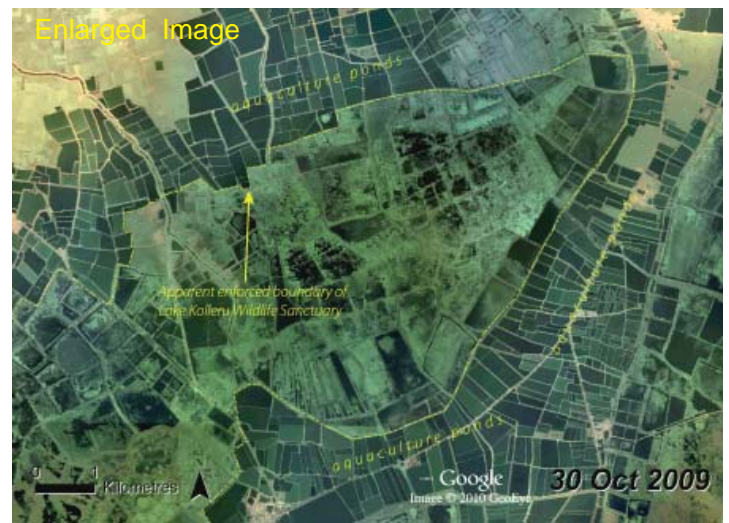
Figure 5: High resolution satellite data from late 2009 shows the intensity and proximity of ongoing aquaculture to the sanctuary.

some ponds remain (Figures 3c, 4 and 5) and there are signs that illegal ponds are returning to the sanctuary. Where ponds were breached, in many cases much of the enclosure remains and continues to alter the hydrological and ecological functions of these areas (Rao and others 2008). In addition, the surrounding area between the Godavari and Krishna deltas is seeing continued expansion and intensity of aquaculture (Figure 4). Water quality continues to be threatened as industry, agriculture, and aquaculture activity discharges large amounts of major nutrients, trace metals, and pesticides into the lake (Adhikari and others 2009). This example shows the danger of sacrificing many undervalued ecosystem services provided by wetlands (such as flood regulation and wildlife habitat) to obtain marketable goods in the short term. It also provides a cautionary lesson: improving management and regulations can reverse the worst impacts but implementing policies beforehand would prevent them.
